RE: 101 Mary Jess Road – Suncoast Building Materials
Landscape progress
CPH Project No. E7601

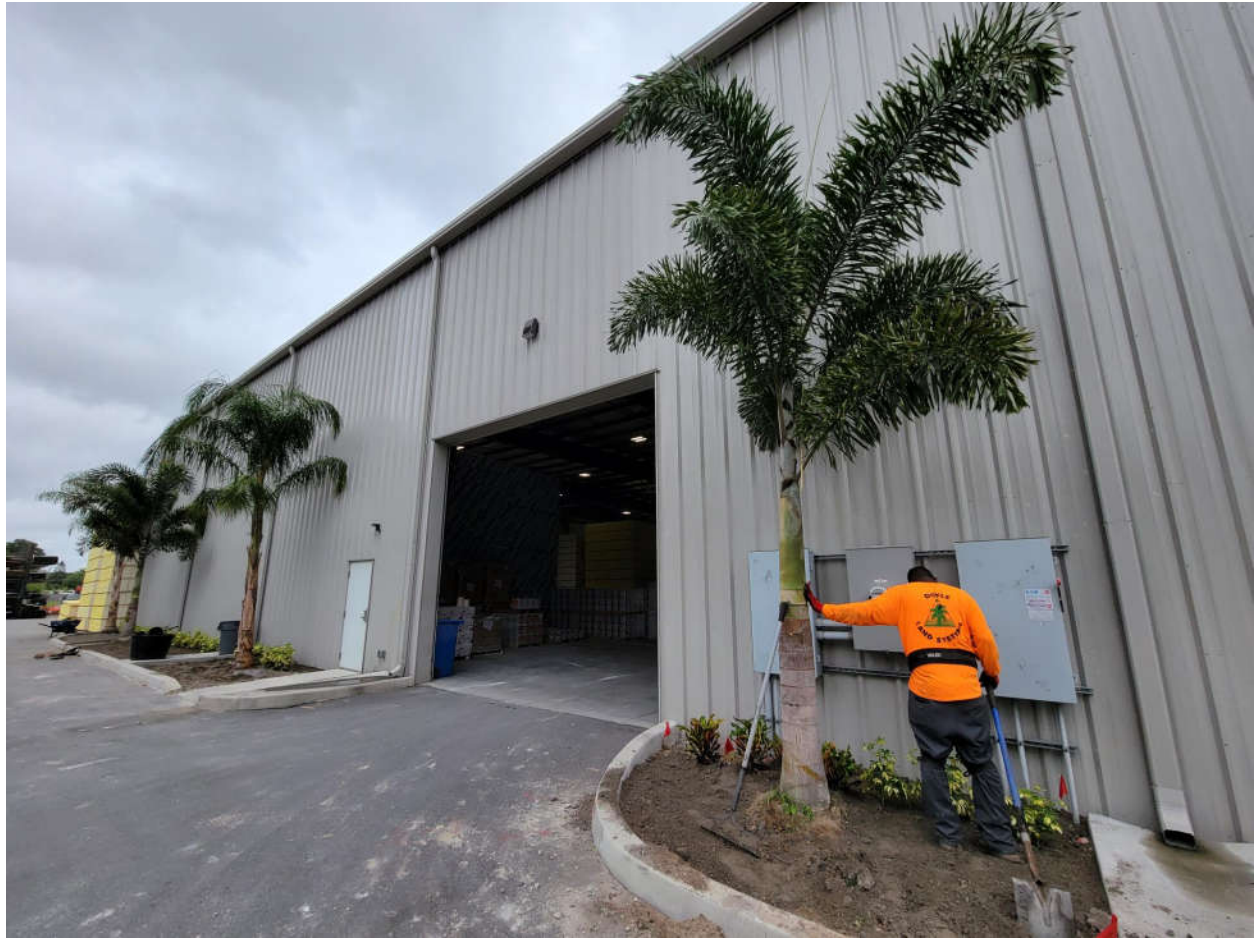
The below photo shows nice looking palms, but may be too short. I won't know for sure until I measure them in the field. They are supposed to be a minimum of 15' -18'CT (clear trunk) minimum, per the landscape table excerpt from the drawings below. Clear trunk is measured to where the fronds (leafs) come out of the trunk. Assuming the man next to the palm is around 6', it is doubtful that the clear trunk of the palm is at 15' Ht.

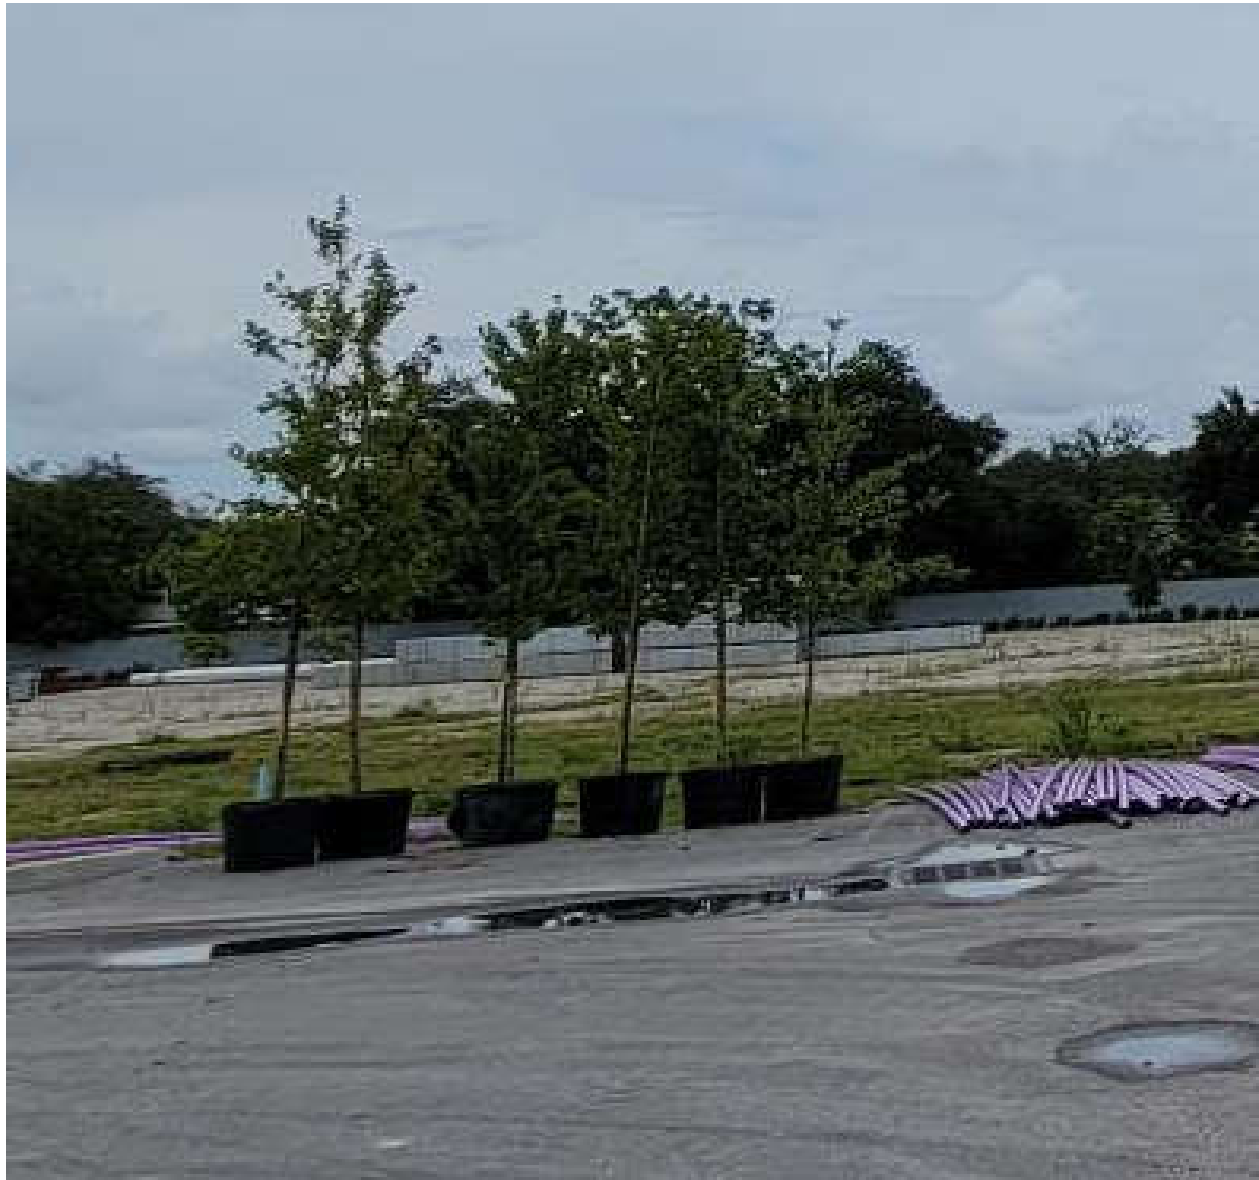
Below appear to be the Live Oaks for the north buffer. I will need to check the caliper and height in the field.

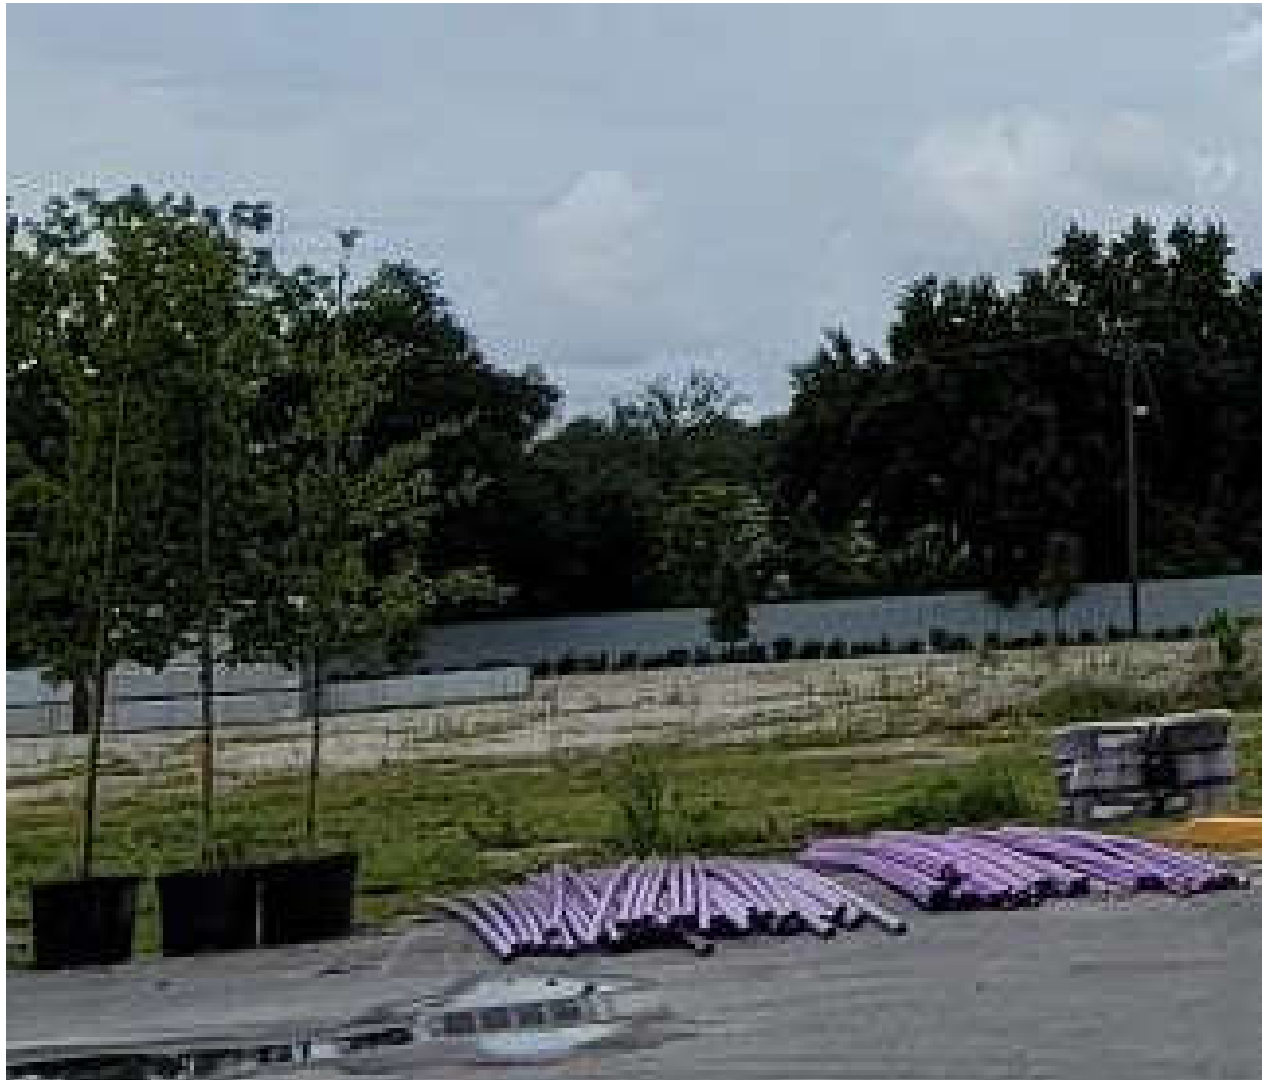
I zoomed into the above photo, to show that the hedge plants and some of the oaks appear to be planted. They also may be placed for planting.

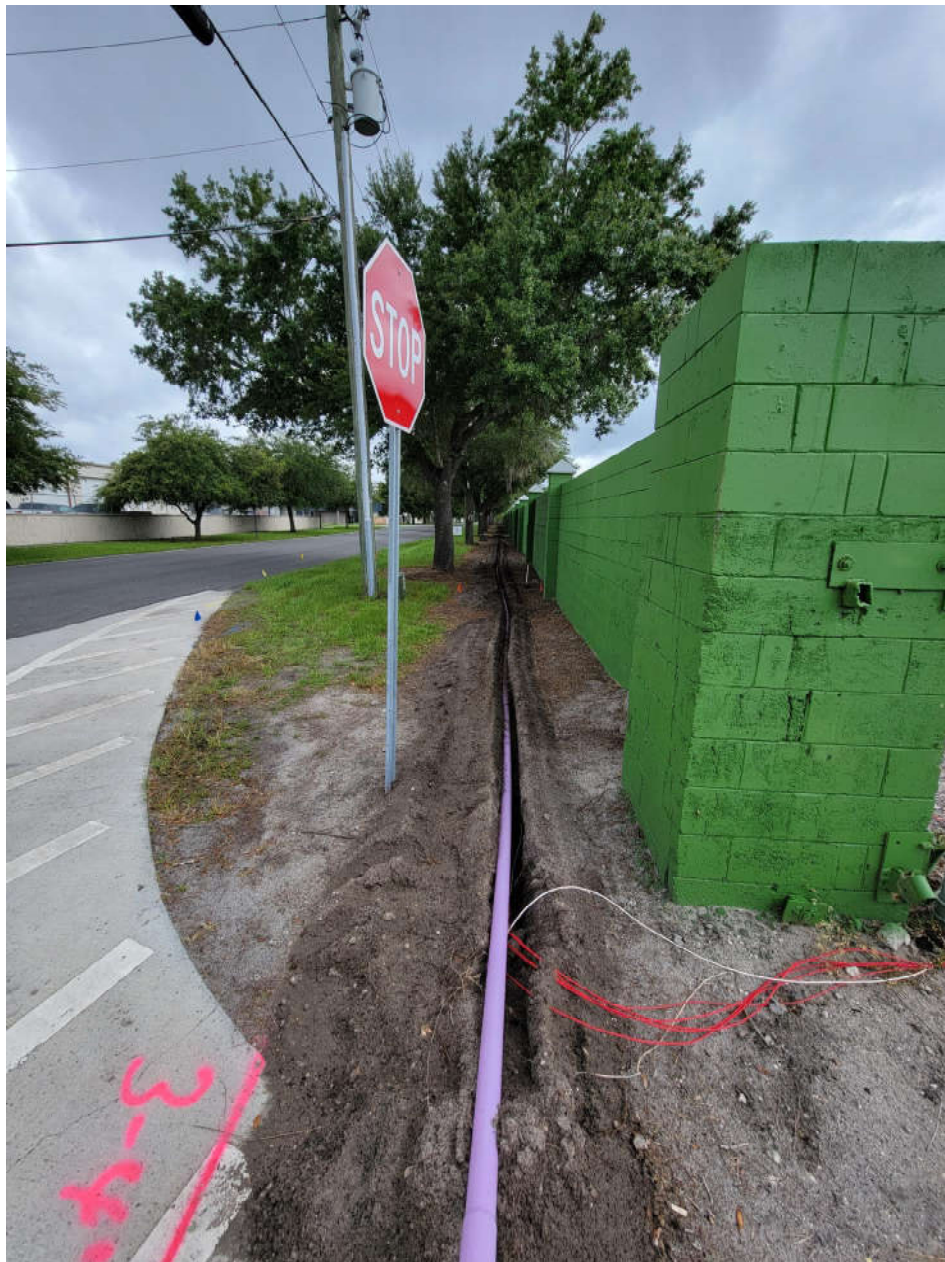
The final photo is extremely troubling. It illustrates that the irrigation contractor trenched the main line through the roots of the existing live oak trees. If a trencher was used, it would have ripped through the roots, instead of providing clean cut. The ripped roots are more subject to infection and disease than if cleanly cut and pruned. The contractor was supposed to place the mainline on the north side of the wall, or jack and bore the pipe under the roots, per my note #8 on my January 21, 2021 comments. In that note, I specifically stated the following; “*Relocate the main line to the north of the wall to avoid trenching through the roots of the existing oak trees. The alternative is to keep the line on the south side and add a note to jack and bore under the tree roots for a distance based on a radius of 1’ per DBH” of tree trunk measured at 4.5’ above grade. Trenching through the tree roots is not an option if these trees are to be preserved*”. In their March 16, 2021 response, Mr. Rick Abt of FEG stated; “***The routing of the irrigation main has been revised to show it north of the screen wall as suggested.***”

As you can see, they placed the main line on the south side of the wall and didn’t jack and bore the lines under the tree roots.

In addition, if they cut structural roots, the trees will be more inclined to fall towards the road in high windstorm events. If they fall, they will also take down the power lines.

I recommend that an ISA arborist, hired by the City, to inspect the trees to tell us whether they have caused irreversible damage to these trees as it can take up to five years for the damage to manifest. The ISA arborist can also calculate a value to the trees.
